## Many Innovations Make Light Work *Dingman Drive Bridge Repaired Using a Suite of Cost-Saving Innovations*

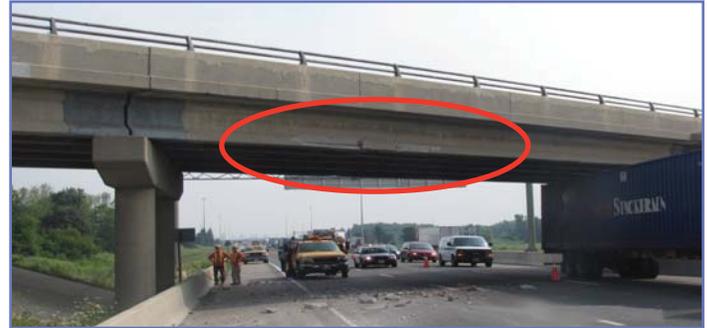
On August 3, 2010, a truck carrying a hydraulic excavator struck the four-span Dingman Drive Bridge over the westbound lanes of Highway 401 near London, Ontario. The truck hit three out of five pre-stressed concrete bridge girders, resulting in extensive damage. Several innovative products and processes were used to perform the repairs, resulting in cost and time savings for the ministry compared to full girder replacement.

Damage to the Dingman Drive Bridge, looking eastward.

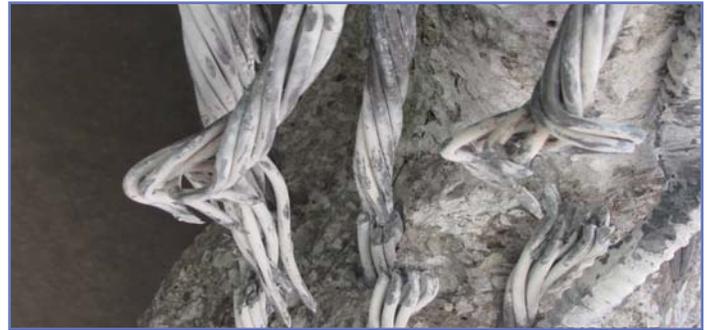
Collision-damaged strands on one of the bridge girders.

Developed in the United States, the *Grabb-It*® is a coupler system that permanently reconnects broken strands in bridge girders, to restore the load carrying capacity of the structure, without having to replace the damaged girders. The *Grabb-It*® device is attached to each end of the severed strand and a threaded coupler (similar to a turnbuckle) is tightened, thereby reinstating the prestressing force in the strand. Although MTO has been aware of the *Grabb-It*® system for a number of years, this repair project was the ministry's first opportunity to use the device. Before the couplers were used on the repair itself, MTO staff practised with the *Grabb-It*® on a model and developed a detailed procedure for the contractor to install the devices. Working with the *Grabb-It*® on site proved more difficult than expected to obtain the desired force in the strands. Force in each strand was determined using a torque wrench to tighten the coupler device and measuring the elongation of the strand. A total of six *Grabb-It*® couplers were installed on two girders, reinstating the pre-stressing force in the girders close to their pre-collision status.

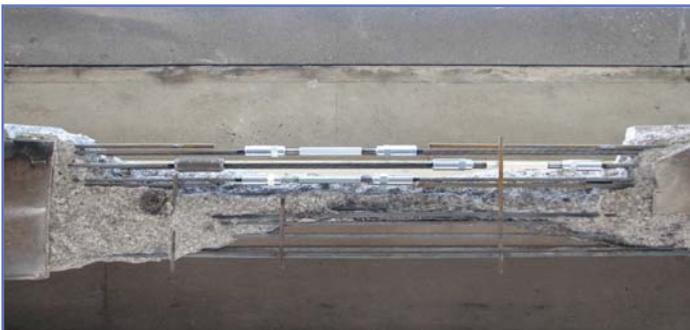
Using the *Grabb-It*® splice coupler system to re-tension girder strands.

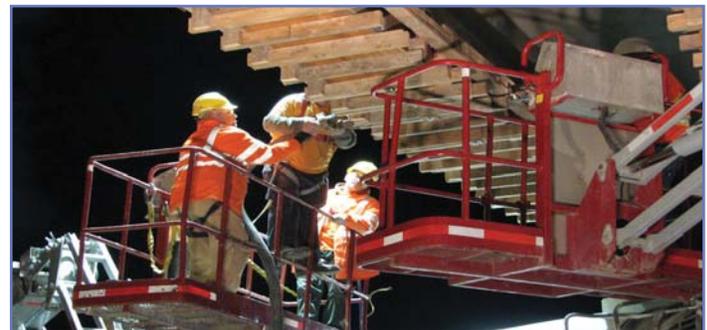
Workers pumping Self Consolidating Concrete to reinstate damaged girder.

**Self Consolidating Concrete (SCC)** was used to repair the damaged concrete girders. SCC is a highly flowable concrete that does not require vibration-based consolidation and can be readily pumped. It is well suited for use where there are tight confines within a given structural repair and concrete consolidation is a concern. Although the installation of *Grabb-It*® couplers caused significant congestion around the exposed prestressing strands and reinforcing steel in the repair areas, the use of SCC resulted in a high quality, durable concrete that required minimal finishing when the forms were removed. >

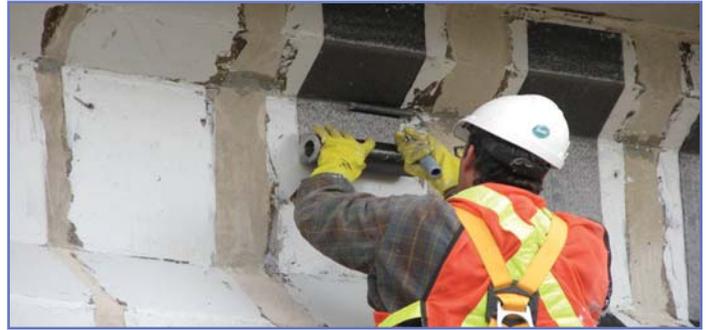
Application of CFRP strips with a roller.

Sheets of woven **Carbon Fibre-Reinforced Polymer (CFRP)** fabric were placed over the concrete repair areas to further strengthen and protect the girders. CFRP fabric is light and can be readily attached to the contours of a concrete girder with an epoxy adhesive system. Three layers of CFRP strips were installed on the underside of the girders and evenly spaced vertical strips of CFRP were installed on the webs of the girders using a multi-step process. The proprietary process included diamond grinding all sharp concrete edges, application of a primer and an epoxy putty, rolling the CFRP fabric onto the epoxy putty, coating the CFRP with a saturant and finally covering the entire repair area with an ultra-violet protective coating.

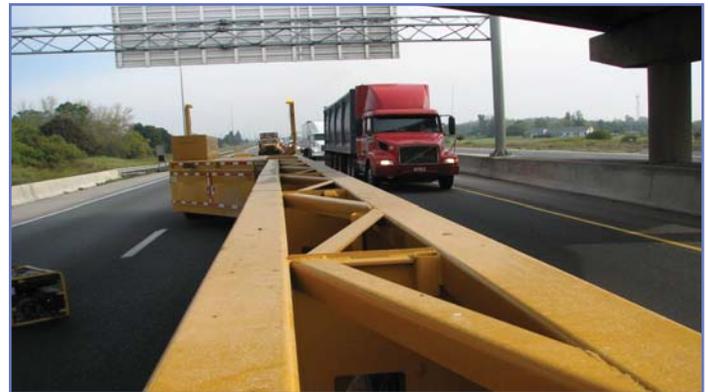
Mobile Traffic Barrier in use under the Dingman Drive Bridge.

A **Mobile Traffic Barrier** was used for the duration of the Dingman Drive Bridge repairs to protect construction workers from freeway traffic. The mobile barrier unit consists of a trailer that is towed into place by a standard truck tractor and then parked to provide worker protection. First used by MTO on a project on Highway 115, the Mobile Traffic Barrier continues to impress contractors and staff in several ministries because of its ease and speed of set-up compared with conventional work zone protection equipment, such as temporary concrete barriers. To minimize disruption to Highway 401 traffic, two of the three westbound lanes were closed on a nightly basis to complete the repairs on the Dingman Drive Bridge. The Mobile Traffic Barrier was removed each morning, opening all lanes during peak traffic hours.
